NIWA Project: WPL13501

Effects of proposed Waitaha HEP scheme on bank stability at powerhouse

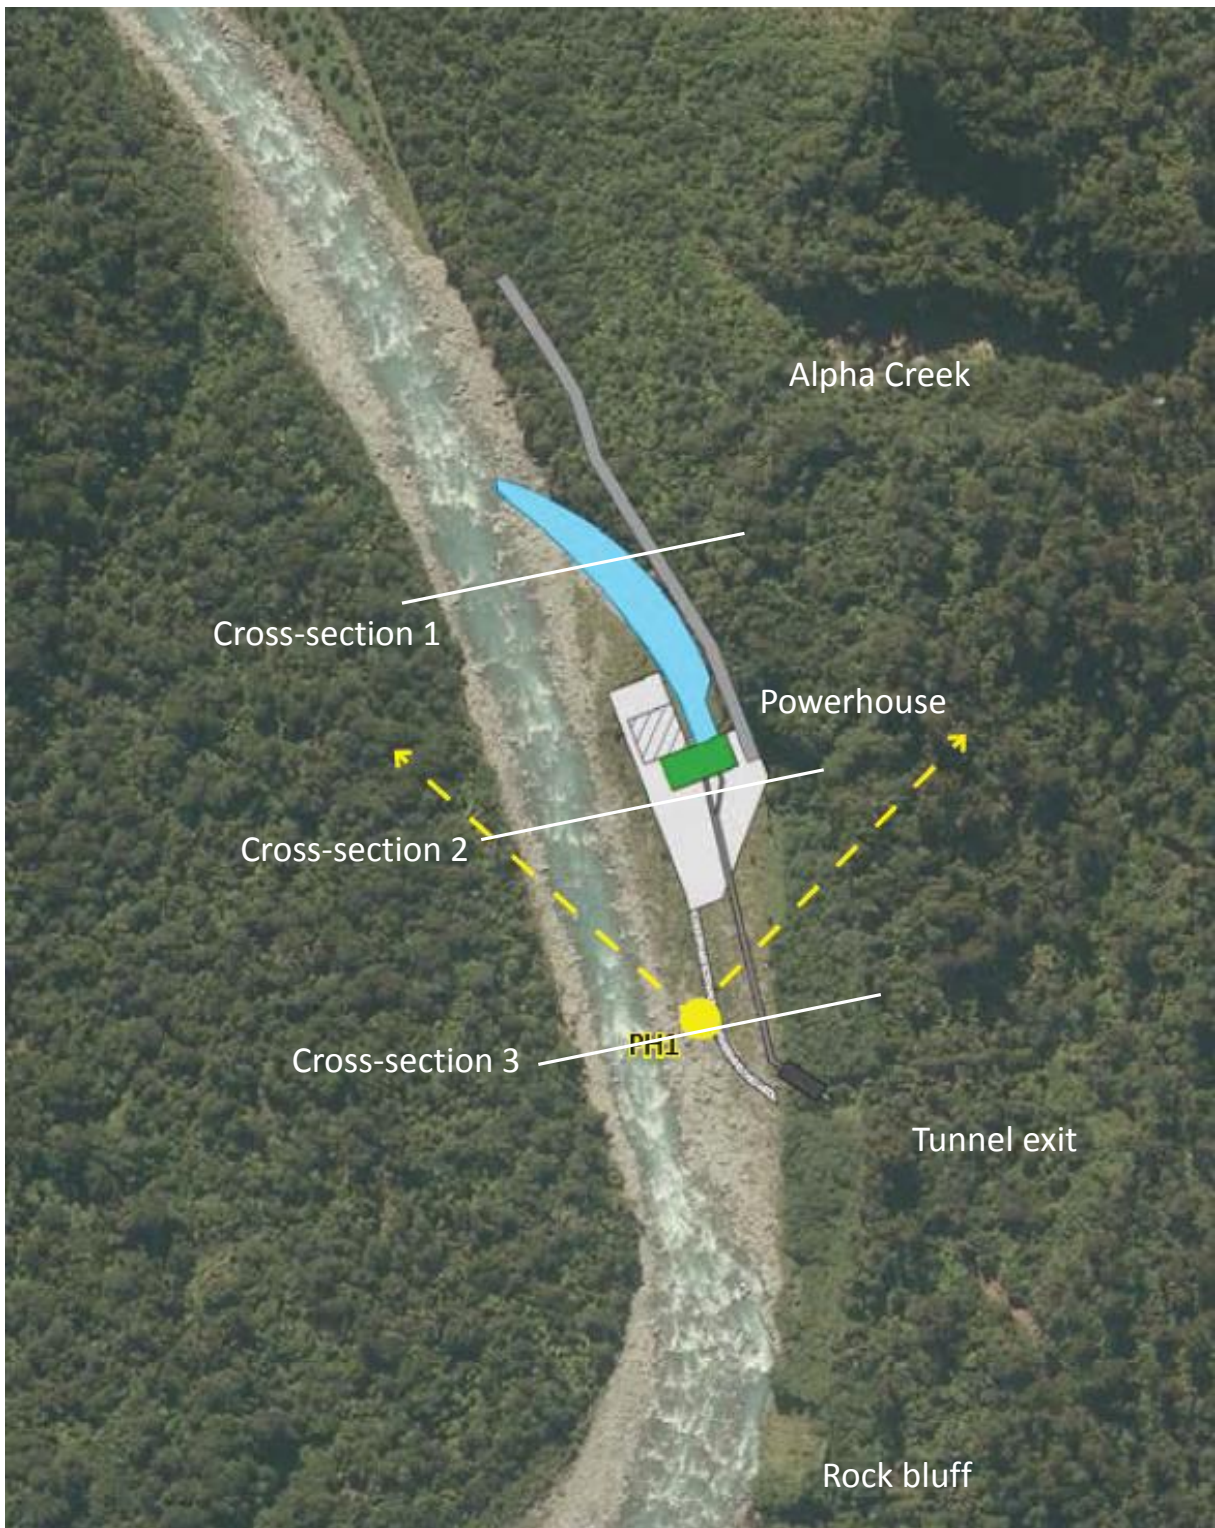
Figure 1: The proposed powerhouse near Alpha Creek. Flow is bottom to top. Taken from Boffa Miskell Plan PH1.

The scheme proposal involves building a powerhouse on the short span of low, tussock-and-scrub-covered terrace on the Waitaha right bank, immediately upstream from Alpha Creek (Figure 1). The diversion tunnel will exit at the upstream end of this terrace, with the water routed along a short span of pipe into the powerhouse. Since the terrace is relatively low above the river (5-6 m), it will be necessary to build a stopbank to protect the canal and powerhouse from floods. This stopbank will reduce the conveyance area for floods large enough to spill over the terrace, and there is the potential that this could force more of the flow along the left bank, causing it to erode. The question is: how much erosion could be caused by the stopbank?

I located the riverside edge of the stopbank and the powerhouse wall by scaling off the photomap shown in Figure 1. I assumed the top of both had an RL of 132.5 m. I assumed the stopbank had a side-batter of 1:2.

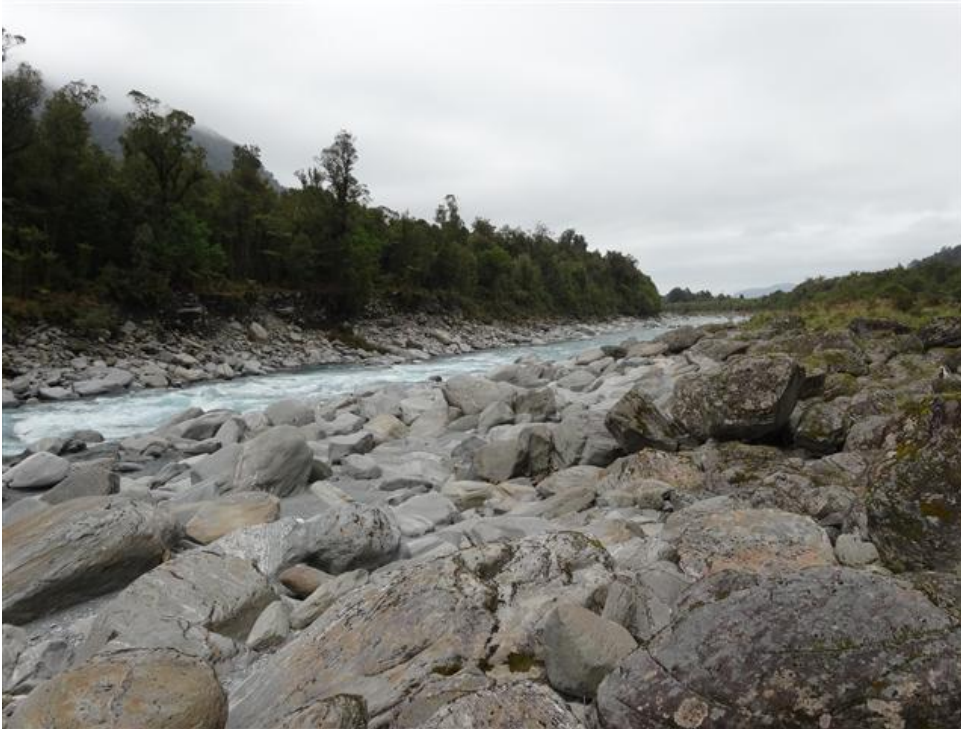
Figure 2: View downstream of the Waitaha channel beside the Alpha Creek terrace (on right).

Currently, the Waitaha River runs beside the terrace in a straight, boulder-bed channel (Figure 2). Boulder size has not been measured, but my visual estimate of the median size is about 600-700 mm (say 650 mm). The right bank terrace has a shallow flood-overflow channel running beside the slope toe and draining into Alpha Creek. The left bank is cut into a higher (10 m high) forested terrace formed of material that ranges in size grade from sand through boulders (Figure 3). The lower bank to the level of the right bank terrace is an armoured beach formed of boulders. The upper bank is near-vertical, and shows signs of recent erosion. The beach appears to have been formed as a lag as the bank has retreated. The Waitaha flow is deflected off a bedrock outcrop on the right bank at the apex of the bend immediately upstream of the Alpha Creek terrace. So the left bank opposite the powerhouse site is already prone to erosion, but its rate of erosion appears limited by natural armouring.

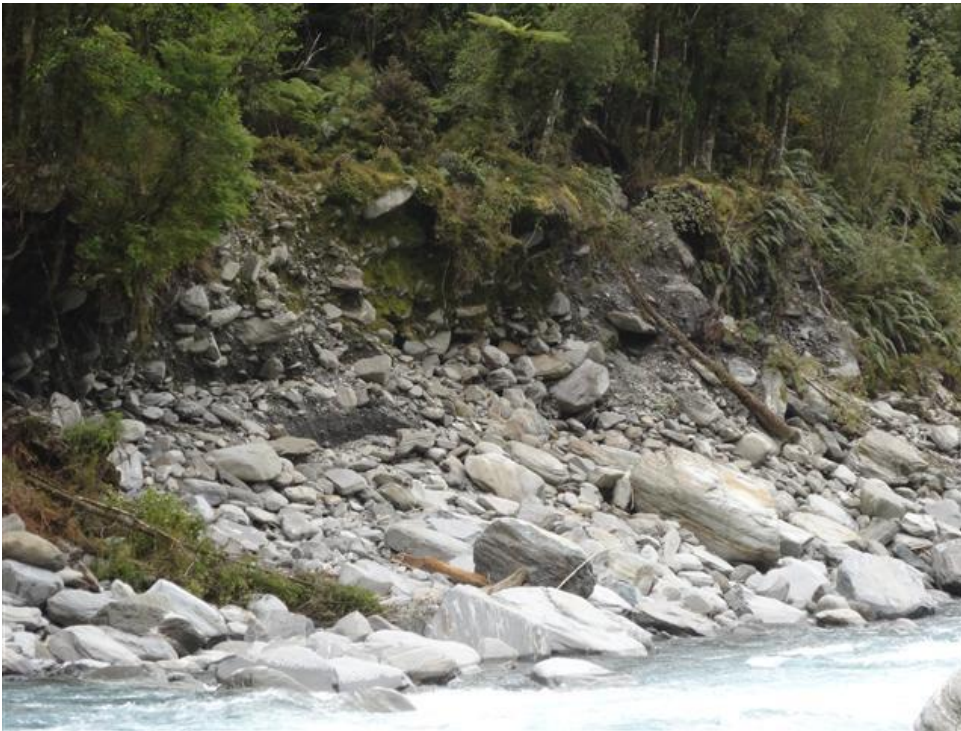
Figure 3: The Waitaha left bank opposite the powerhouse site.
